# PESADONA (SERIES A)

Polished finish and Brushed finish (stainless steel AISI 304 and 316) KALLOS PESADONA (KDSA) is HEAVY DUTY chaneel of Stainless Steel profile offering a generous visible strip reveal of Stainless Steel enhancing the installation. These profiles offer superb resistance to principal chemical and atmospheric agents and are particularly recommended to be used as divider in between different type of finishes in zones such as food processing industries, breweries, dairies, hospitals and external applications and wet area. Its smooth and non-porous surface makes it especially difficult for the adhesion and survival of bacteria and/or other microorganisms.

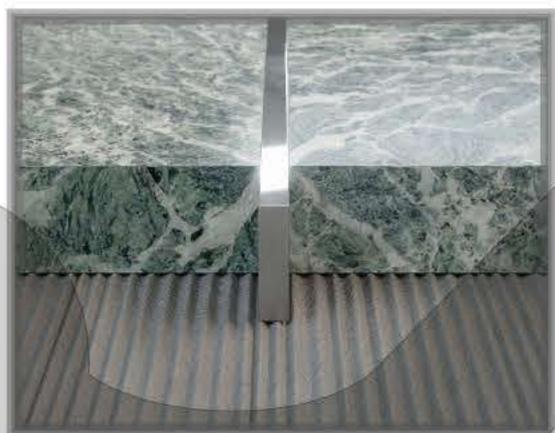
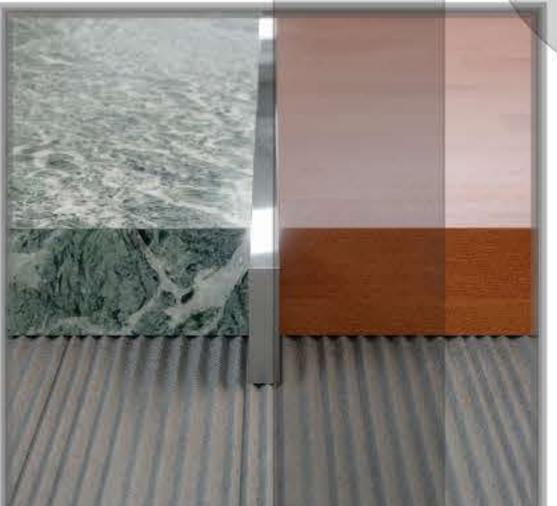
Polished and Bru Stainless		
AISI 304 and 316 with protection film - bar length 2.44 meter Size can be customized *			
ARTICLE	H (mm)	W ( mm )	L(m)
KDSA-PS-H-W-XXX	10,15,20,25,30,40 50,60,70,80,90,100	02,03,05,06,08,10,12	2.44
KDSA-BS-H-W-XXX	10,15,20,25,30,40 50,60,70,80,90,100	02,03,05,06,08,10,12	2.44

- Select the profile in the required material and finish.
- Apply the tiles adhesive onto the area of application.
- 3 Lay the KDSA profile.
- 4 Continue laying the profiles by aigning the profile flush with the finish.
