PESADONA (SERIES B)

Polished finish and Brushed finish (stainless steel AISI 304 and 316)

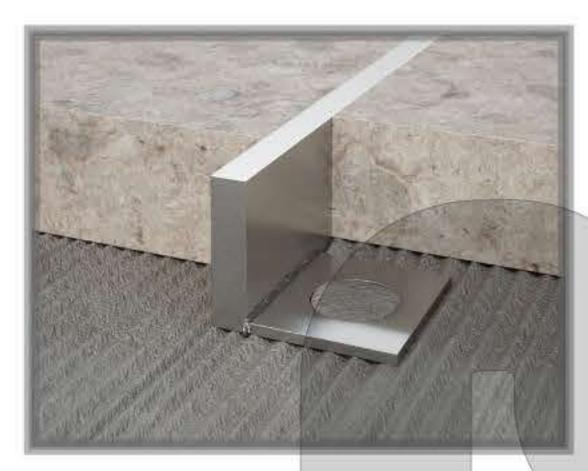
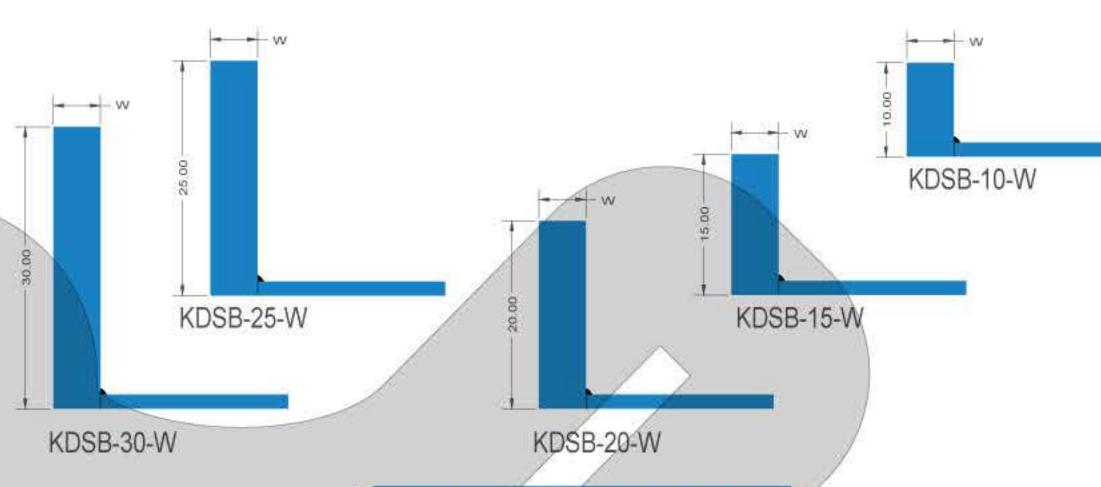
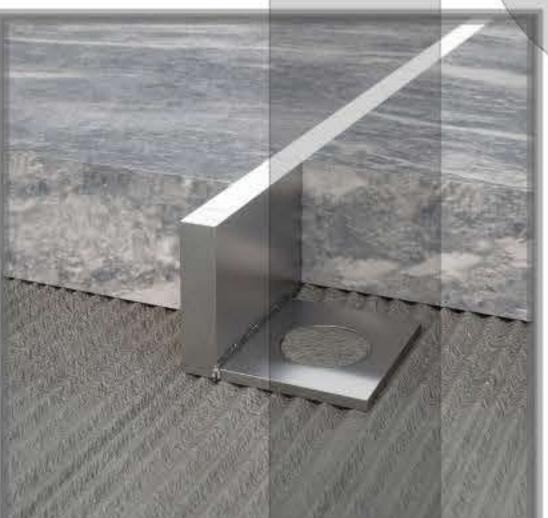
KALLOS PESADONA (KDSB) is HEAVY DUTY chancel of Stainless Steel profile offering a generous visible strip reveal of Stainless Steel enhancing the installation. These profiles offer superb resistance to principal chemical and atmospheric agents and are particularly recommended to be used as divider in between different type of finishes in zones such as food processing industries, breweries, dairies, hospitals and external applications and wet area. Its smooth and non-porous surface makes it especially difficult for the adhesion and survival of bacteria and/or other microorganisms.

Stainless steel AISI 304 and 316 with protection film - bar length 2.44 meter Size can be customized * H(mm) W (mm) L(m) **ARTICLE** 10,15,20,25,30,40 KDSB-PS-H-W-XXX 02,03,05,06,08,10,12 2.44 50,60,70,80,90,100 10,15,20,25,30,40 KDSB-BS-H-W-XXX 02,03,05,06,08,10,12 2.44 50,60,70,80,90,100

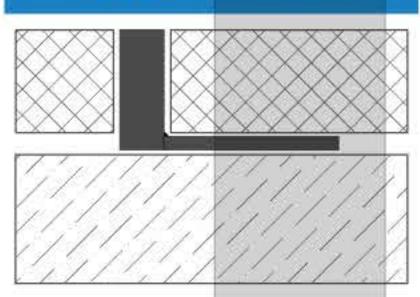
Laying instructions

- 1 Select the profile in the required material and finish.
- 2 Apply the tiles adhesive onto the area of application.
- 3 Lay the KDSB profile.
- 4 Continue laying the profiles by aigning the profile flush with the finish.
