# BORDEONA ( SERIES A )

Polished finish and Brushed finish  
( stainless steel AISI 304 and 316 )

**KALLOS BORDEONA ( KBOS )** is a triangle chaneel of Stainless Steel profile offering a generous visible strip reveal of Stainless Steel enhancing the installation. These profiles offer superb resistance to principal chemical and atmospheric agents and are particularly recommended to be used as divider in between different type of finishes in zones such as food processing industries, breweries, dairies, hospitals and external applications and wet area. Its smooth and non-porous surface makes it especially difficult for the adhesion and survival of bacteria and/or other microorganisms.

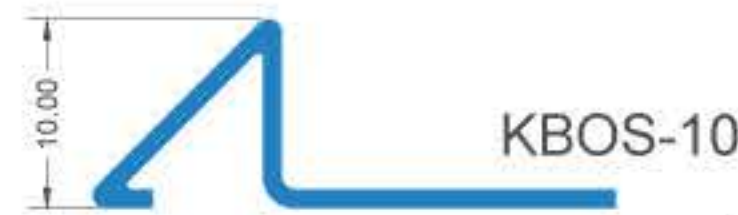
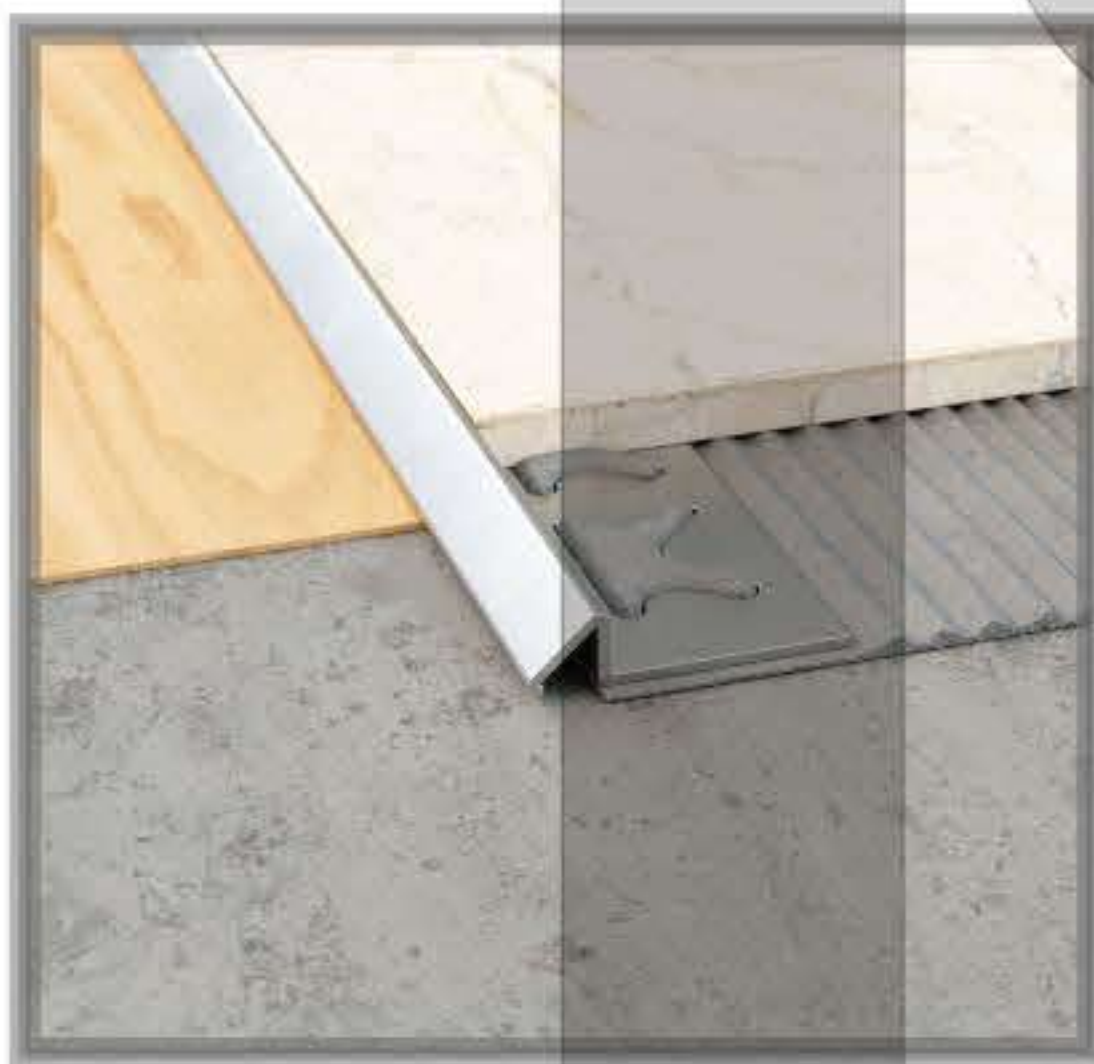
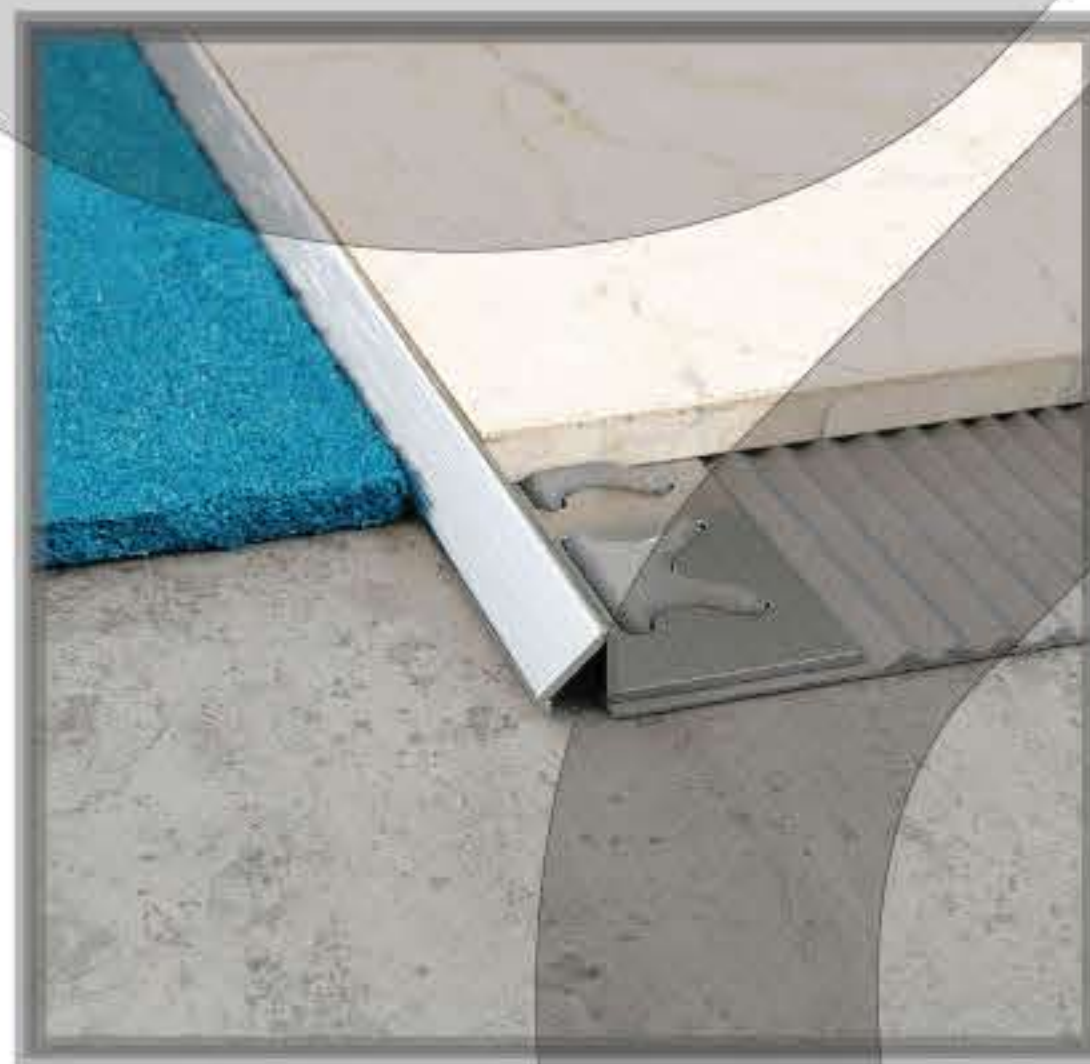
Polished and Brushed Finish Stainless steel		
AISI 304 and 316 with protection film - bar length 2.44 meter, H ( 8 to 12 ) <i>Size can be customized *</i>		
ARTICLE	H ( mm )	L ( m )
KBOS-PS-08	08	2.44
KBOS-PS-10	10	2.44
KBOS-PS-12	12	2.44
KBOS-BS-08	08	2.44
KBOS-BS-10	10	2.44
KBOS-BS-12	12	2.44
