PESADONA (SERIES C)

Polished finish and Brushed finish
(stainless steel AISI 304 and 316)

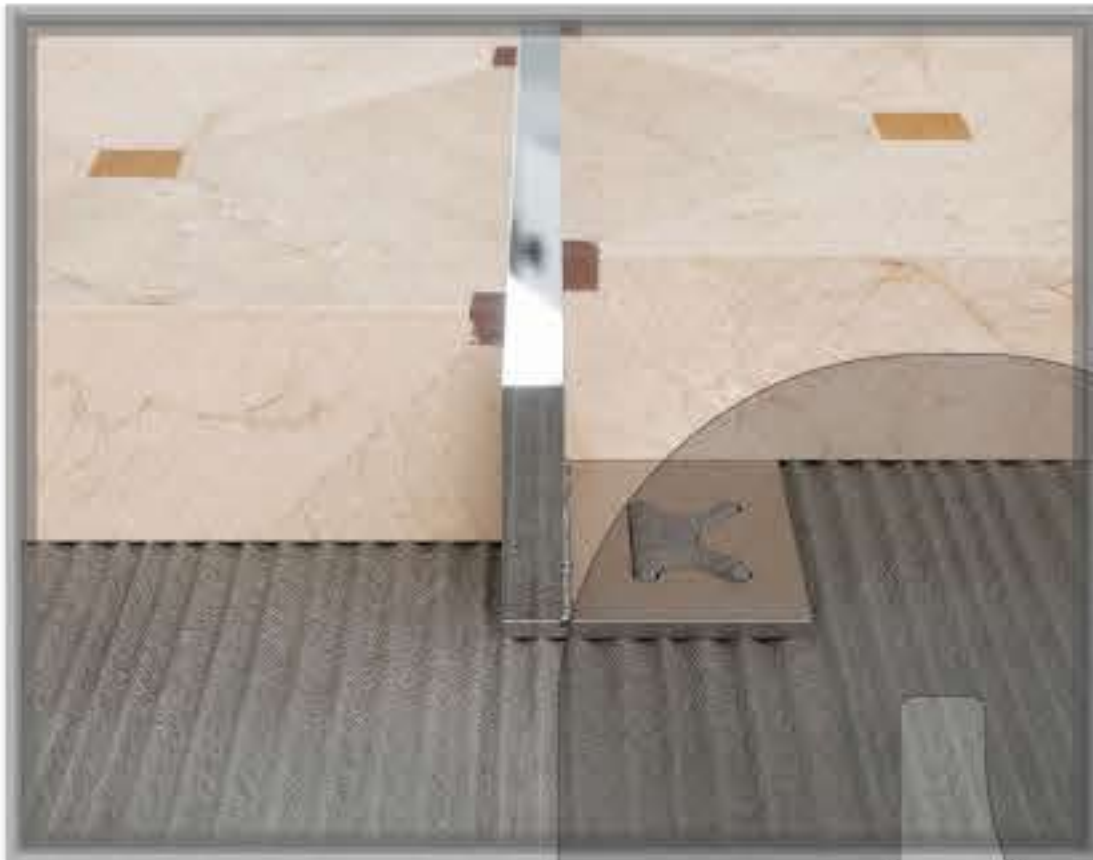
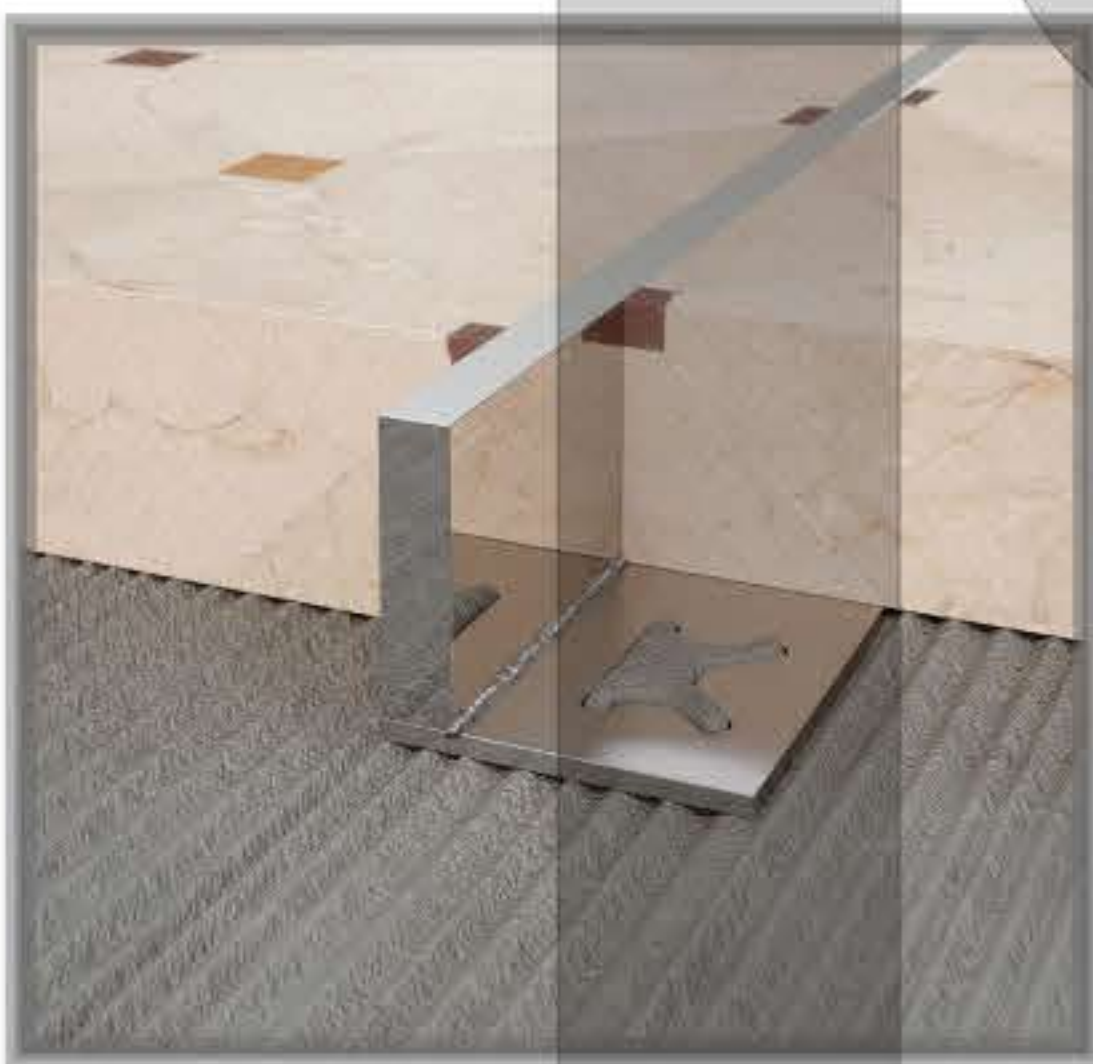
KALLOS PESADONA (KDSC) is HEAVY DUTY chaneel of Stainless Steel profile offering a generous visible strip reveal of Stainless Steel enhancing the installation. These profiles offer superb resistance to principal chemical and atmospheric agents and are particularly recommended to be used as divider in between different type of finishes in zones such as food processing industries, breweries, dairies, hospitals and external applications and wet area. Its smooth and non-porous surface makes it especially difficult for the adhesion and survival of bacteria and/or other microorganisms.

Polished and Brushed Finish Stainless steel

AISI 304 and 316 with protection film - bar
length 2.44 meter
Size can be customized *

ARTICLE	H (mm)	W (mm)	L (m)
KDSC-PS-H-W-XXX	10,15,20,25,30,40 50,60,70,80,90,100	02,03,05,06,08,10,12	2.44
KDSC-BS-H-W-XXX	10,15,20,25,30,40 50,60,70,80,90,100	02,03,05,06,08,10,12	2.44
