PRO SUELONA

Polished and Brushed finish
(stainless steel AISI 304 and 316)

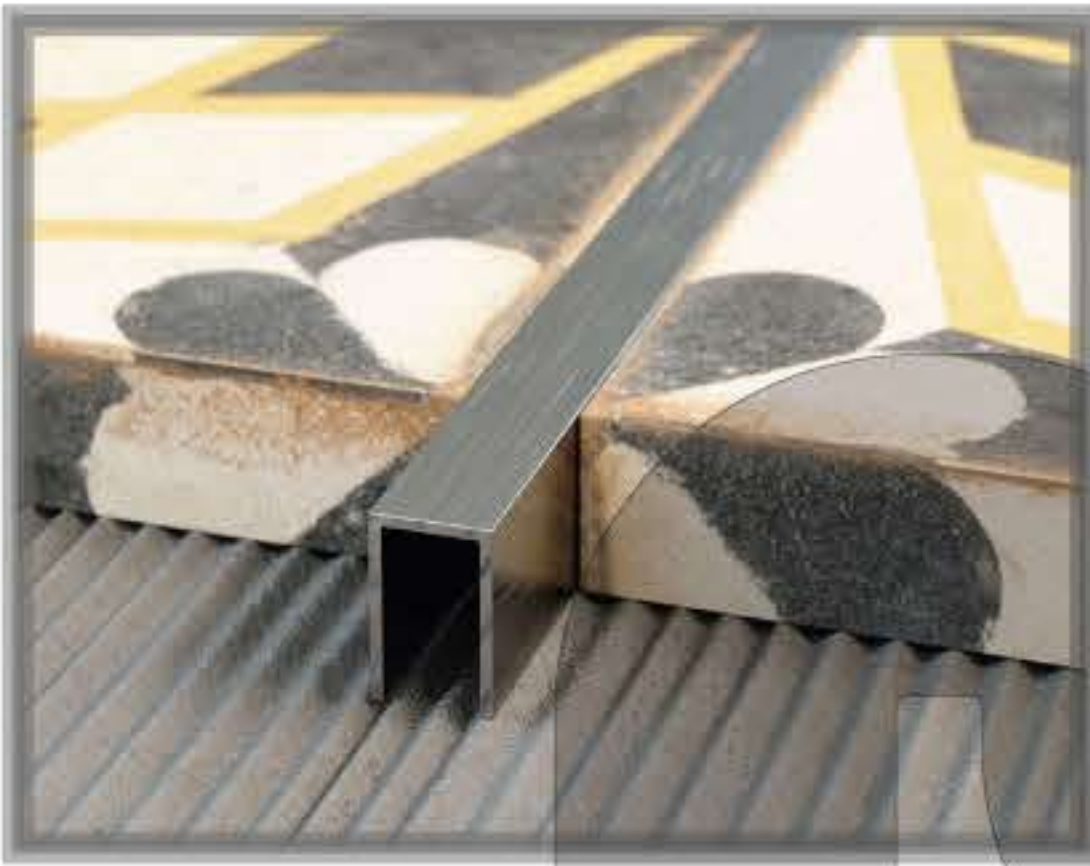
KALLOS PRO SUELONA (KPSSA) is a channel of Stainless Steel profile offering a generous visible strip reveal of Stainless Steel enhancing the installation. These profiles offer superb resistance to principal chemical and atmospheric agents and are particularly recommended to be used as divider in between different type of finishes in zones such as food processing industries, breweries, dairies, hospitals and external applications and wet area. Its smooth and non-porous surface makes it especially difficult for the adhesion and survival of bacteria and/or other microorganisms.
KALLOS Stainless Steel Profiles are supplied with protection film for added protection, before, during and after application - as standard.

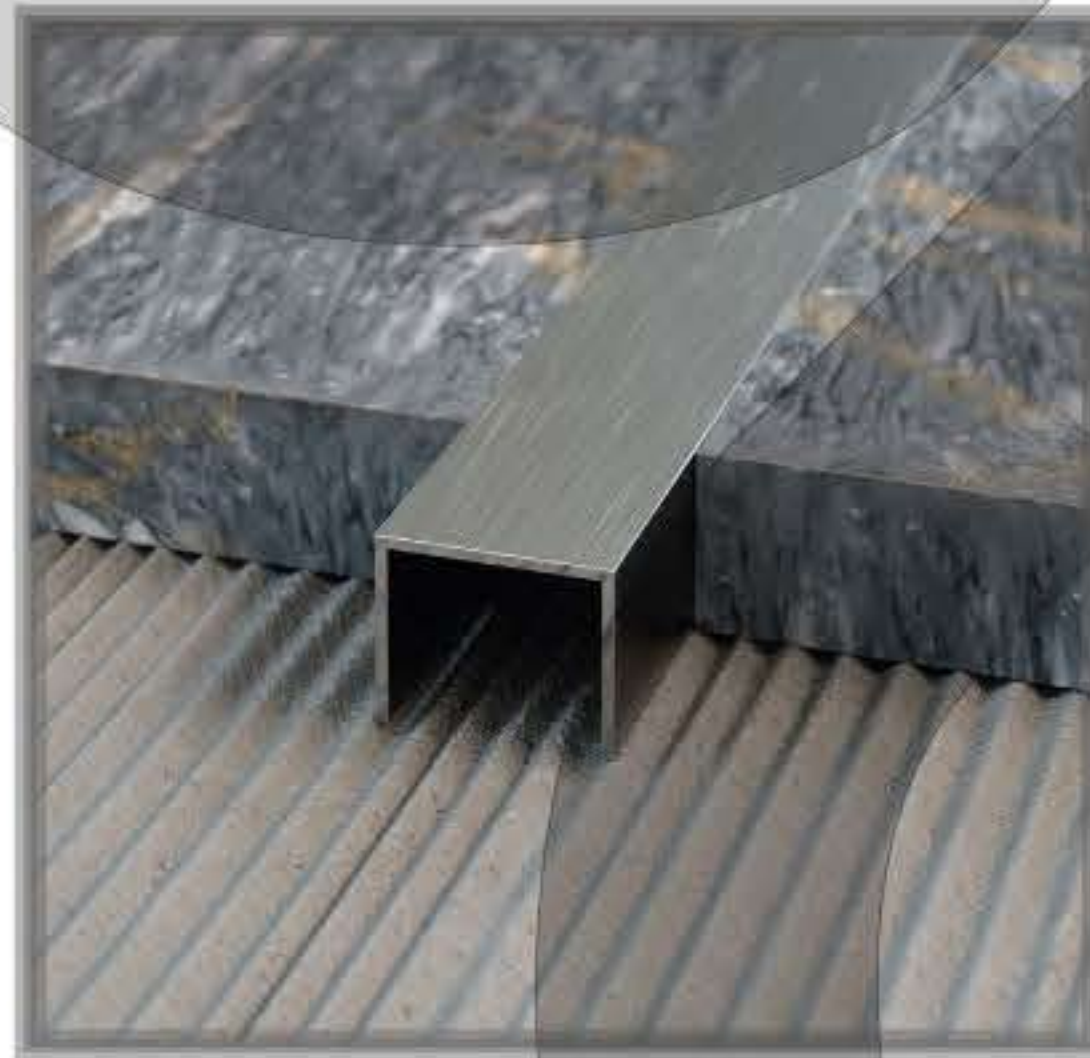
Polished and Brushed Finish Stainless steel		
AISI 304 and 316 with protection film - bar length 2.44 meter (W from 10 to 30) and H(10) Size can be customized *		
ARTICLE	W (mm)	L (m)
KPSSA-PS-3	3	2.44
KPSSA-PS-5	5	2.44
KPSSA-PS-8	8	2.44
KPSSA-PS-10	10	2.44
KPSSA-BS-3	3	2.44
KPSSA-BS-5	5	2.44
KPSSA-BS-8	8	2.44
KPSSA-BS-10	10	2.44
