(stainless steel AISI 304 and 316)

KALLOS SUELONA (KSSA) is a chaneel of Stainless Steel profile offering a generous visible strip reveal of Stainless Steel enhancing the installation. These profiles offer superb resistance to principal chemical and atmospheric agents and are particularly recommended to be used as divider in between different type of finishes in zones such as food processing industries, breweries, dairies, hospitals and external applications and wet area. Its smooth and non-porous surface makes it especially difficult for the adhesion and survival of bacteria and/or other microorganisms.

S Profiles

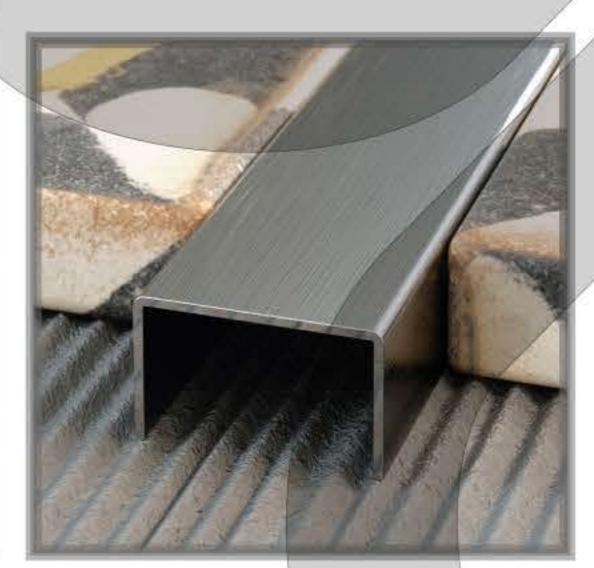
Polished and Brushed Finish Stainless steel

AISI 304 and 316 with protection film - bar length 2.44 meter (W from 10 to 30) and H(10) Size can be customized *

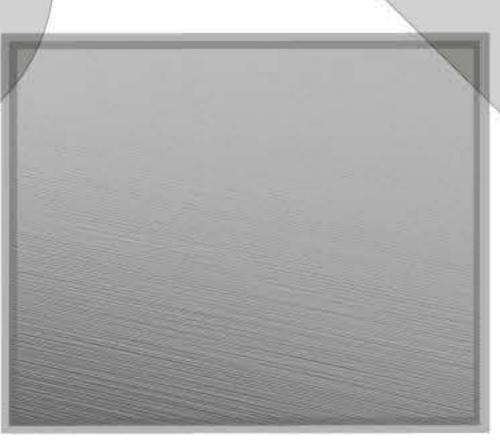
BS Brushed Silver
