TIARONA (SERIES A)

Polished finish and Brushed finish
(stainless steel AISI 304 and 316)

KALLOS TIARONA (KTRS) is a TEE profile of Stainless Steel offering a generous visible strip reveal of Stainless Steel enhancing the installation. These profiles offer superb resistance to principal chemical and atmospheric agents and are particularly recommended to be used as divider in between different type of finishes in zones such as food processing industries, breweries, dairies, hospitals and external applications and wet area. Its smooth and non-porous surface makes it especially difficult for the adhesion and survival of bacteria and/or other microorganisms.

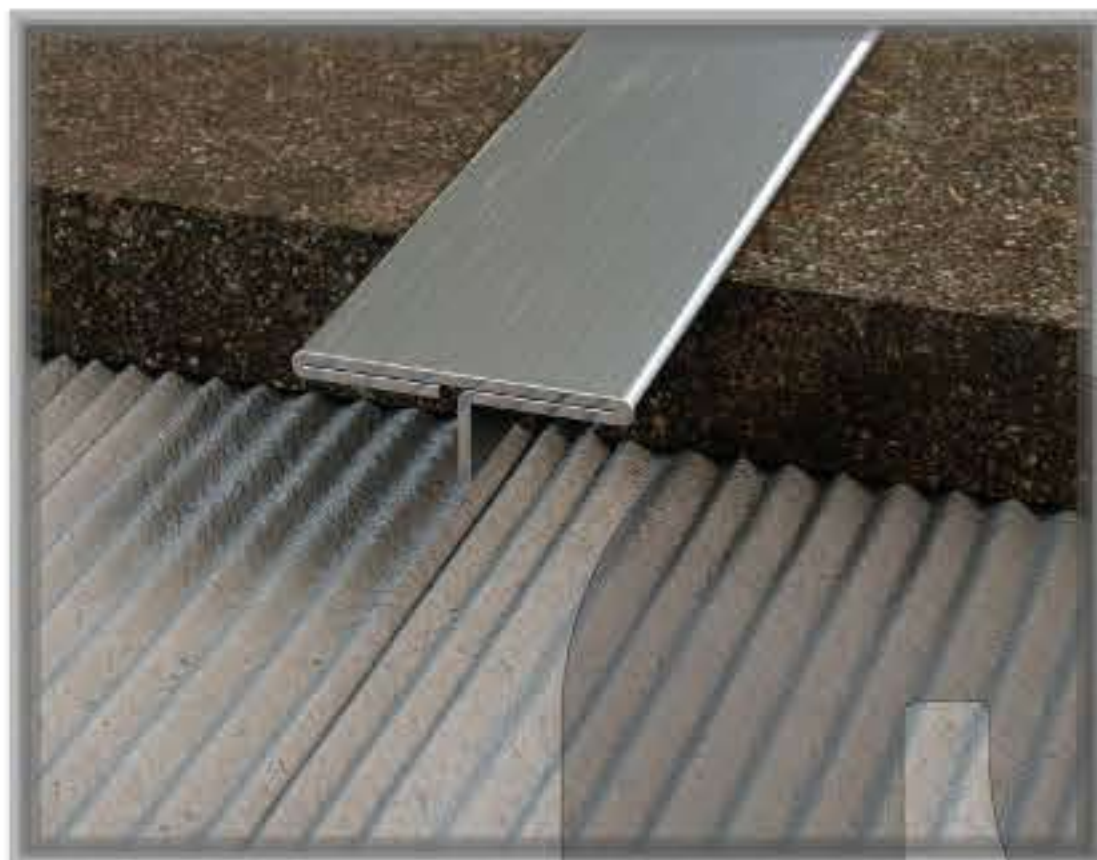
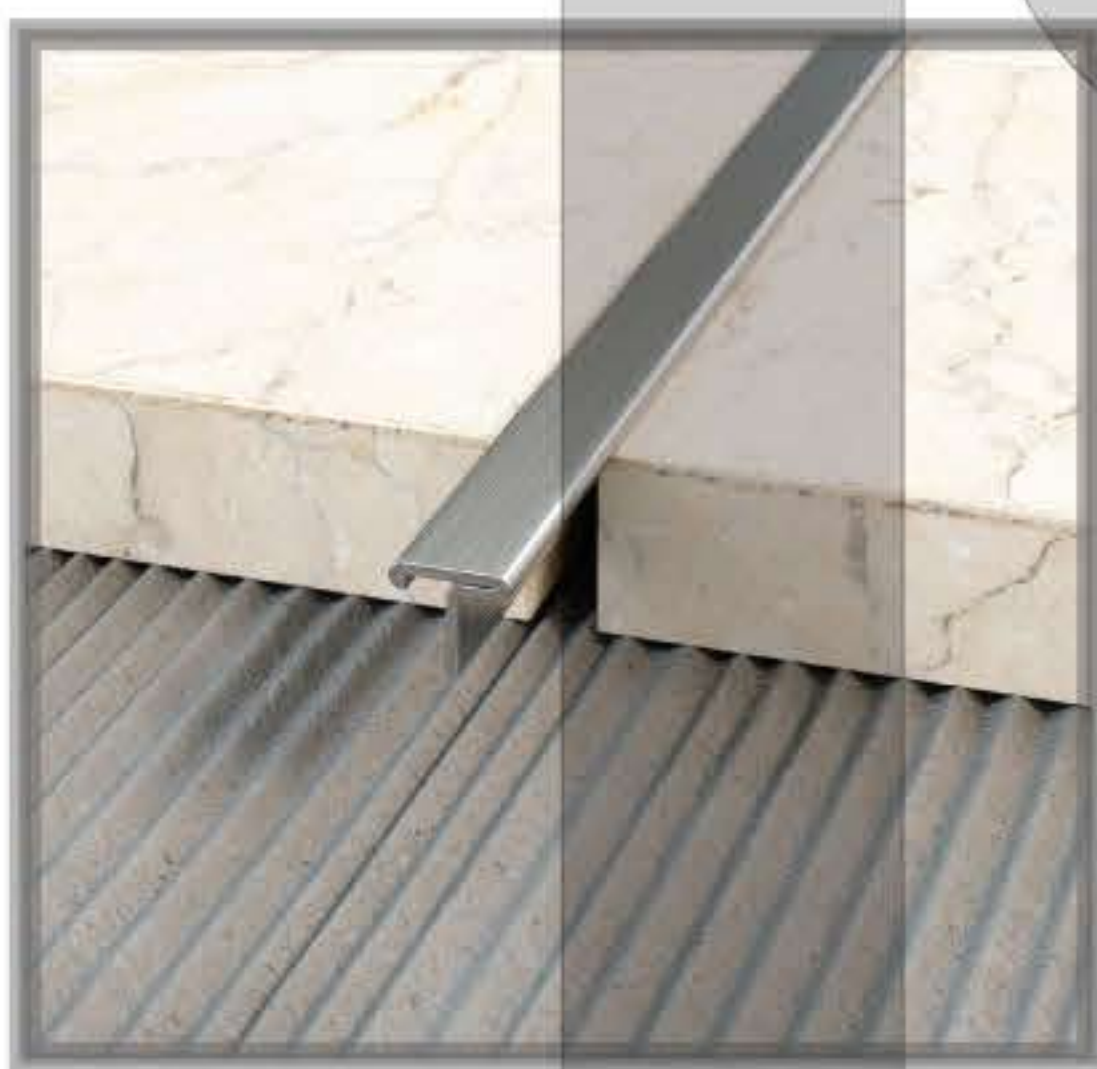
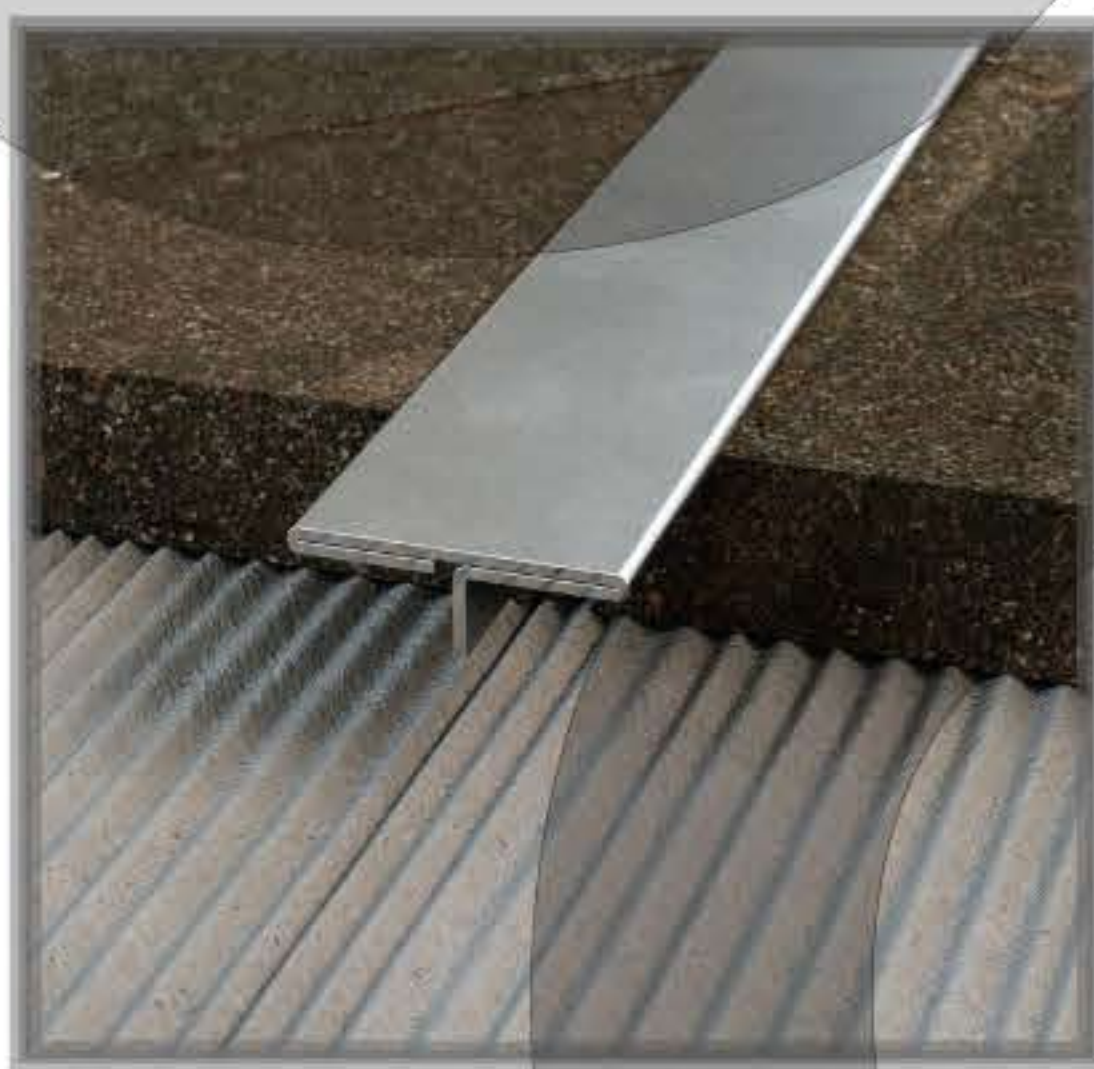
Polished and Brushed Finish Stainless steel

AISI 304 and 316 with protection film - bar length 2.44 meter (W from 6 to 25 MM)
*Size can be customized **

ARTICLE	W (mm)	L (m)
KTRS-PS-W	06,08,10,15,20,25	2.44
KTRS-BS-W	06,08,10,15,20,25	2.44
